**COVE RIVER BASIN  
WEST HAVEN, CONNECTICUT**

**UPPER LAKE PHIPPS  
DAM NO.1 - CT 00109  
DAM NO.2 - CT 00110**

**PHASE I INSPECTION REPORT  
NATIONAL DAM INSPECTION PROGRAM**

**JULY 1980**

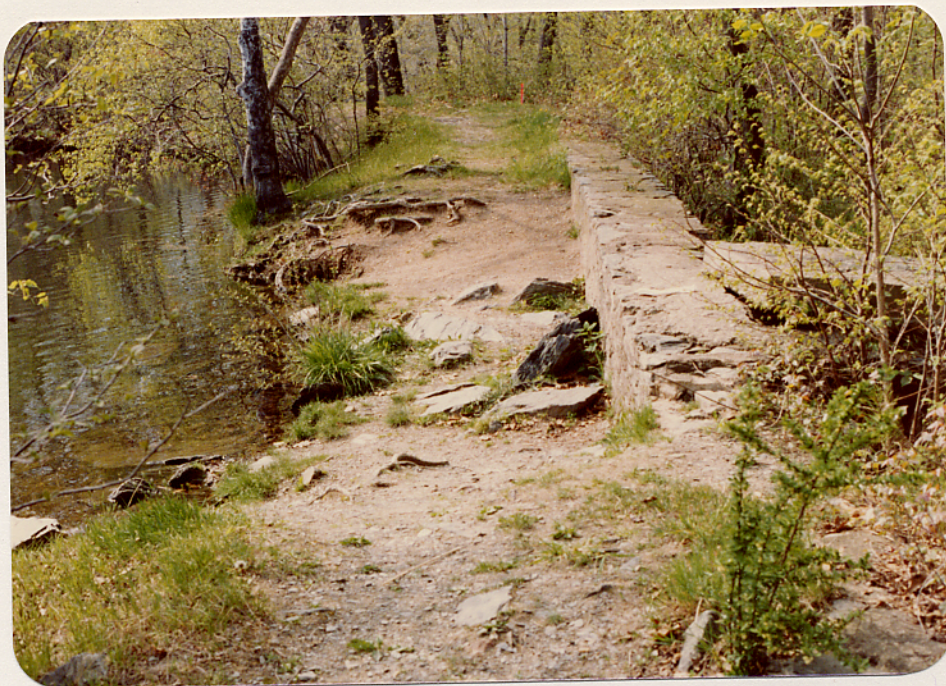
PHOTO NO. 1

The crest of the dam is somewhat irregular with a path worn bare by pedestrian traffic. There is what appears to be a stone masonry corewall, approximately 2.5 feet wide at the top, across the entire length of the dam. The top of the wall is at ground level, Photo 2, with the exception of a 30 foot long section near the downstream stone masonry gate chamber where approximately 2.5 feet of the wall is exposed, Photo 1.

RIGHT SECTION OF DAM NO. 1  
NOTE GATE CHAMBER DOWNSTREAM  
AND EROSION UPSTREAM OF MASONRY WALL

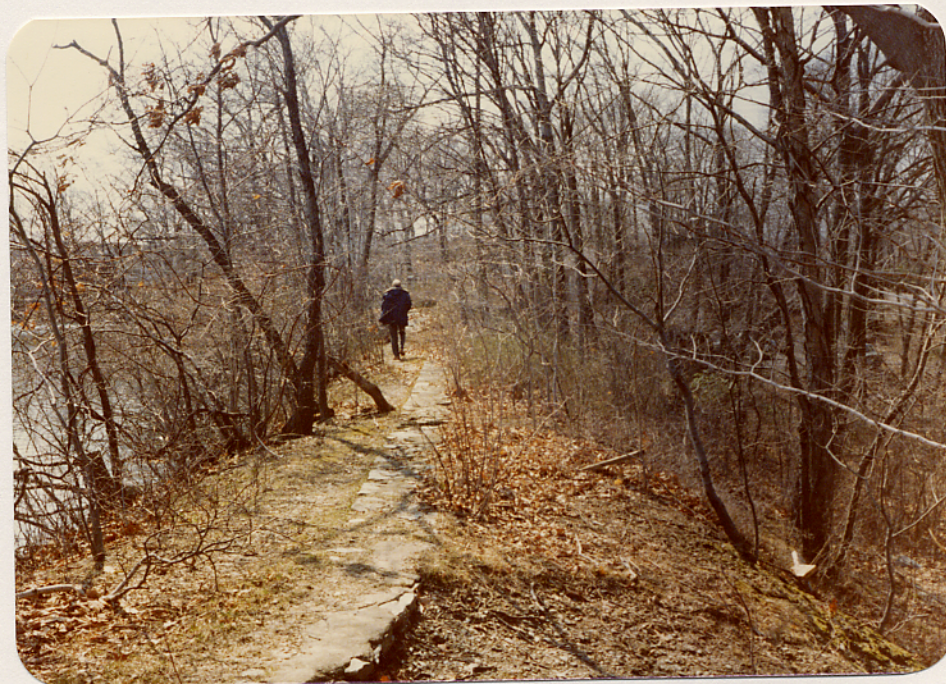
PHOTO NO. 2\*

Brush and small trees growing on the upstream and downstream slopes of Dam No. 1 and Dam No. 2 make it difficult to inspect these areas adequately. Also, if trees are allowed to grow to a large size internal erosion along the root systems may develop or the dams may be damaged by uprooting of the trees during a storm.

LEFT SECTION OF DAM NO. 1  
NOTE BRUSH AND TREE GROWTH  
ON CREST AND SLOPES

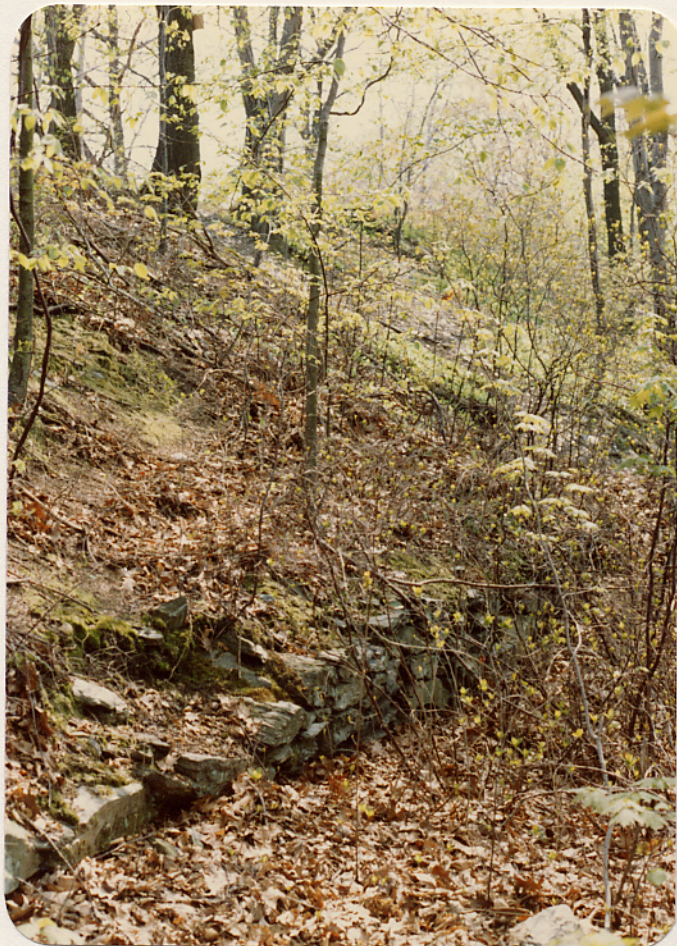
PHOTO NO. 3

Brush, shrubs and small and large trees are growing on the downstream slope of the dam. A small stone wall approximately 40 feet long and 2.5 feet high exists at about the toe of the downstream slope near the left abutment, Photo 3. Seepage was observed discharging at the base of a 3-inch diameter sapling, Photo 4, approximately 10 feet downslope from the small stone wall. The flow was relatively clear with a slight presence of rust-colored floccules. Water was also observed discharging near the toe of the slope in the area of an adjacent sanitary sewer.

STONE WALL ON DOWNSTREAM  
SLOPE OF DAM NO. 1 NEAR  
LEFT ABUTMENT

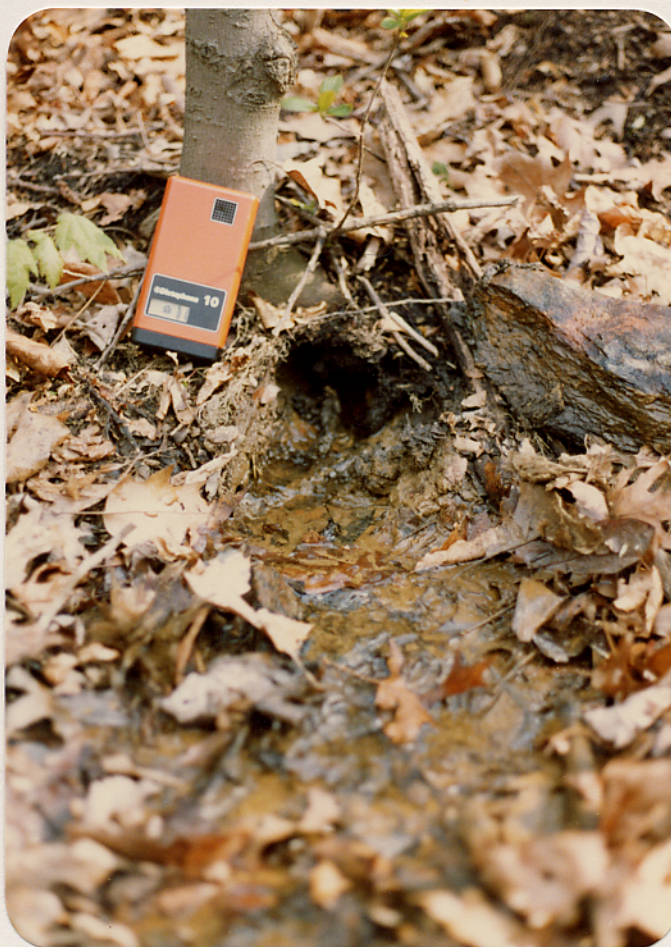
PHOTO NO. 4

Seepage is occurring at the toe of the left section of Dam No. 1. Also, there is discharge of water downstream of the toe of the left section of Dam No. 1, possibly due to seepage through the foundation. Seepage could lead to internal erosion and breaching of the dam if not controlled.

SEEPAGE FROM  
BASE OF SAPLING

It is recommended that a qualified, registered engineer be retained to investigate the seepage at both dams, to oversee tree

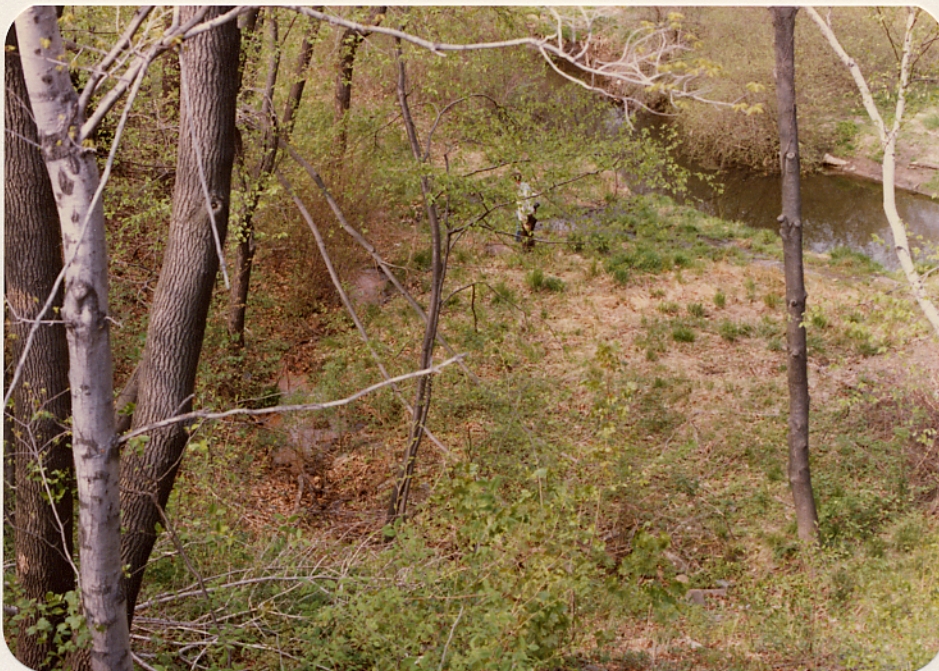
PHOTO NO. 5

There is a large wet area with no discharging water at the downstream toe of the right section of the dam, Photo 5. The standing water contains a large quantity of rust-colored floccules. The remainder of the area is damp and contains moisture loving vegetation. A manhole was present approximately 50 feet downstream of the toe of the dam. The water level within the manhole was about 6 inches below ground surface. The manhole did not appear to be connected to the adjacent sanitary sewer and may be the location of a downstream gate on the low level outlet or blowoff line. A small flow of seepage with an oily sheen and rust-colored floccules was observed downstream from the manhole, Photo 6.

There is a large wet area (with no discharge of flowing water) at the toe of the right section of Dam No. 1. This wet area may be indicative of seepage problems which could eventually cause instability of the dam, if not corrected.

SEEPAGE AREA AT DOWNSTREAM TOE  
OF RIGHT SECTION OF DAM NO. 1

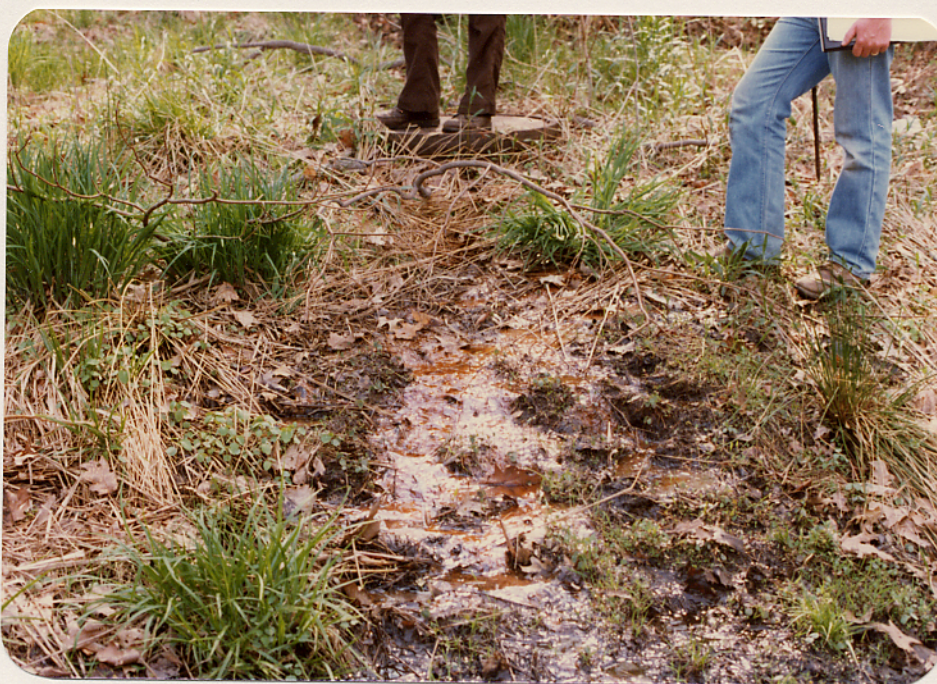
PHOTO NO. 6

There is also reported to be a low level outlet or blowoff at Dam No. 1. A flooded manhole downstream of the toe of the dam may contain the blowoff valve, but it was not confirmed. An upstream intake chamber reportedly contains an inoperative valve but no valve was observed.

SEEPAGE AREA DOWNSTREAM OF MANHOLE  
(POSSIBLE LOCATION OF BLOWOFF VALVE)

and stump removal at both dams, to investigate the significance of the depression on the upstream face of Dam No. 1, to design repairs to the upstream slopes of both dams, and to determine the location and condition of the low level outlet or blowoff line.

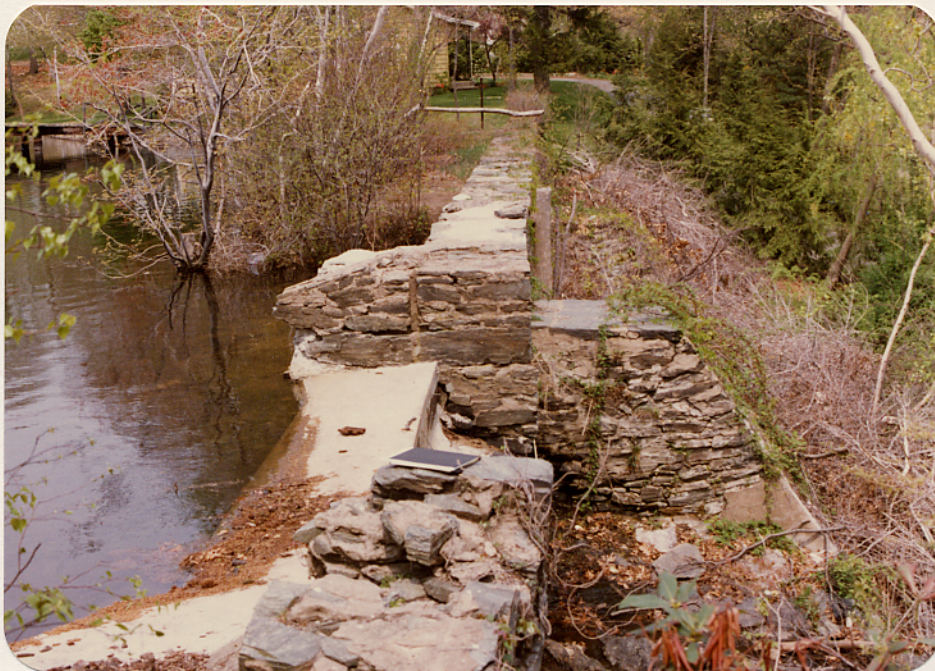
PHOTO NO. 7

The spillway has been recently repaired by placing a concrete cap over the existing stone masonry weir, Photo 7. As was previously noted, the stone masonry walls on either side of the spillway channel have been displaced and are out of plumb. Seepage was observed through the stone masonry portion of the spillway along its entire length. The spillway is founded on ledge and the discharge channel is in ledge.

DAM NO. 2 FROM RIGHT ABUTMENT,  
SPILLWAY IN FOREGROUND

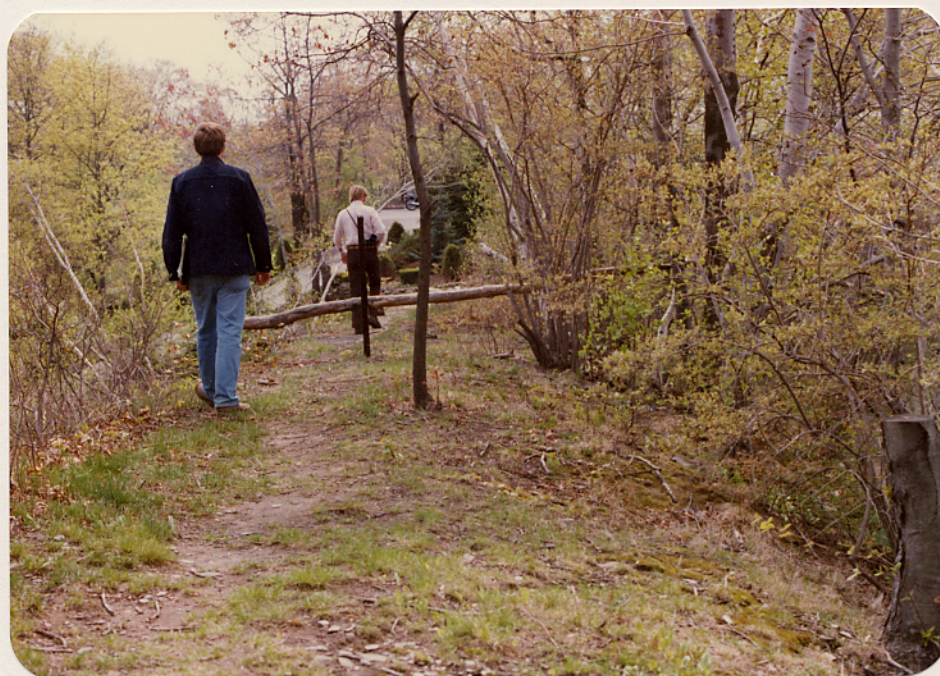
PHOTO NO. 8

A path has been worn along the entire length of the crest. Trees and brush are growing on the crest, Photo 8.

DAM NO. 2 FROM LEFT ABUTMENT.  
NOTE TREES AND BRUSH ON UPSTREAM SLOPE

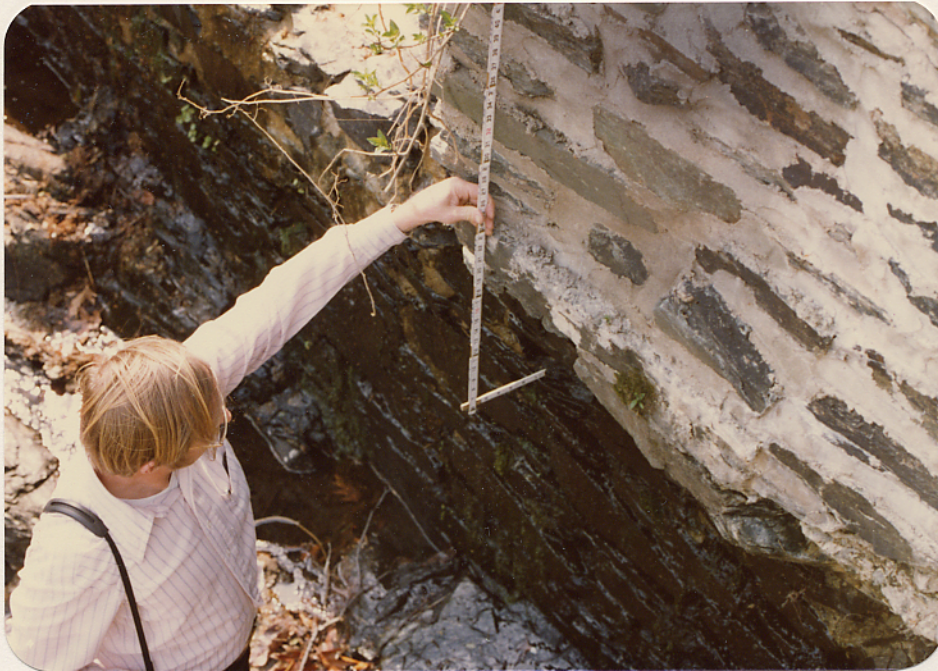
PHOTO NO. 9

The stone masonry and concrete wall appears to have been originally constructed as a stone masonry buttress wall with three stone buttresses. A concrete wall and two concrete buttresses appear to have been added against the stone masonry wall at a later date. The concrete sections are badly deteriorated. The area downstream of the wall is heavily overgrown with brush and appears to be a disposal area for branches and cut brush. Due to the brush and branches it was possible to inspect only the upper 5 feet of the wall. However, seepage was observed through the base of the wall. Several tree stumps up to 6-inches in diameter were observed protruding from the wall. A portion of the wall adjacent to the spillway appears to have been displaced approximately 6 inches laterally, Photo 9.

Continued deterioration and movement of the stone masonry and concrete portions of Dam No. 2 and seepage through the wall may lead to instability of the dam.

MASONRY WALL TO LEFT OF SPILLWAY,  
NOTE APPARENT DISPLACEMENT

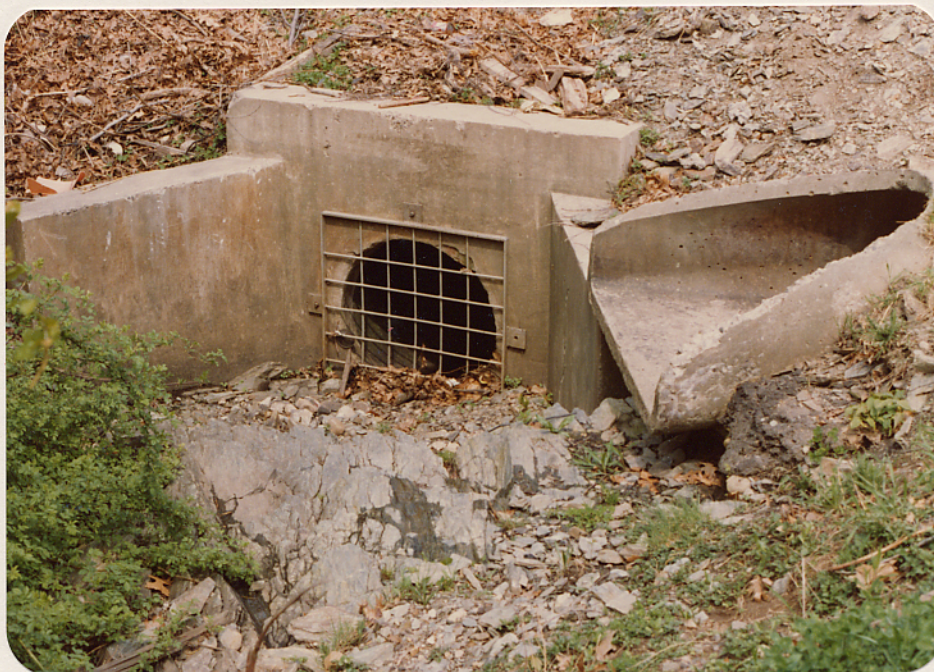
PHOTO NO. 10

30-INCH AND 24-INCH CULVERTS  
UNDER ROADWAY DOWNSTREAM OF SPILLWAY  
NOTE GRATE ON 30-INCH CULVERT

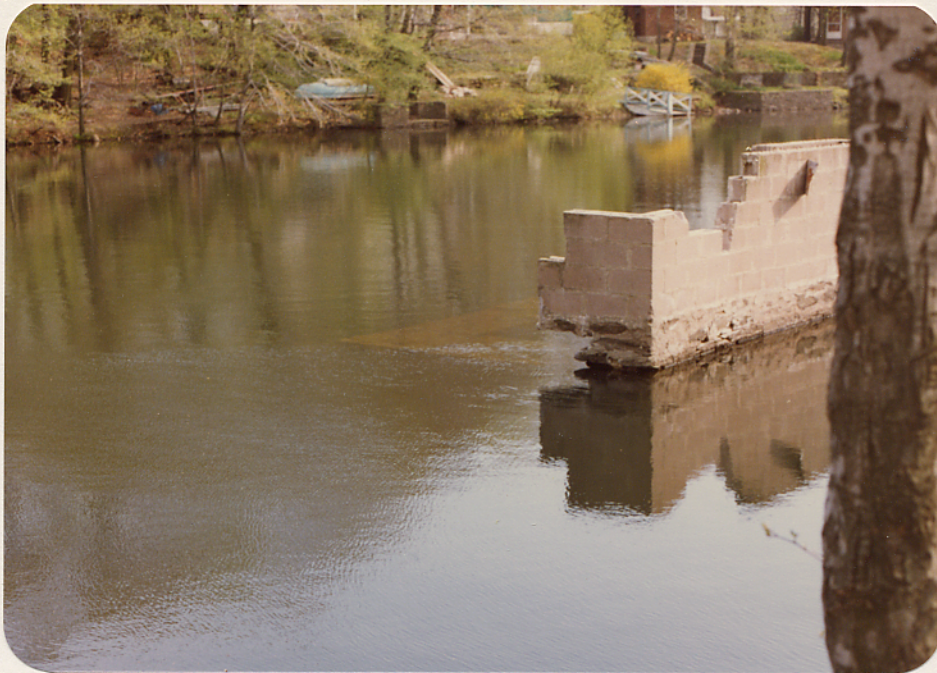
PHOTO NO. 11

The outlet works are located at the right section of Dam No. 1. The remains of an intake structure are located upstream of the dam, Photo 11. A downstream stone masonry gate chamber, Photo 1, is covered by a concrete slab and steel plate. It is reported that there is a downstream gate on the low level outlet or blowoff line that is operated at least once a year. Other than the manhole noted under section 3.1.b., no evidence of a downstream gate or outlet was observed.

REMAINS OF INTAKE STRUCTURE  
UPSTREAM OF DAM NO. 1

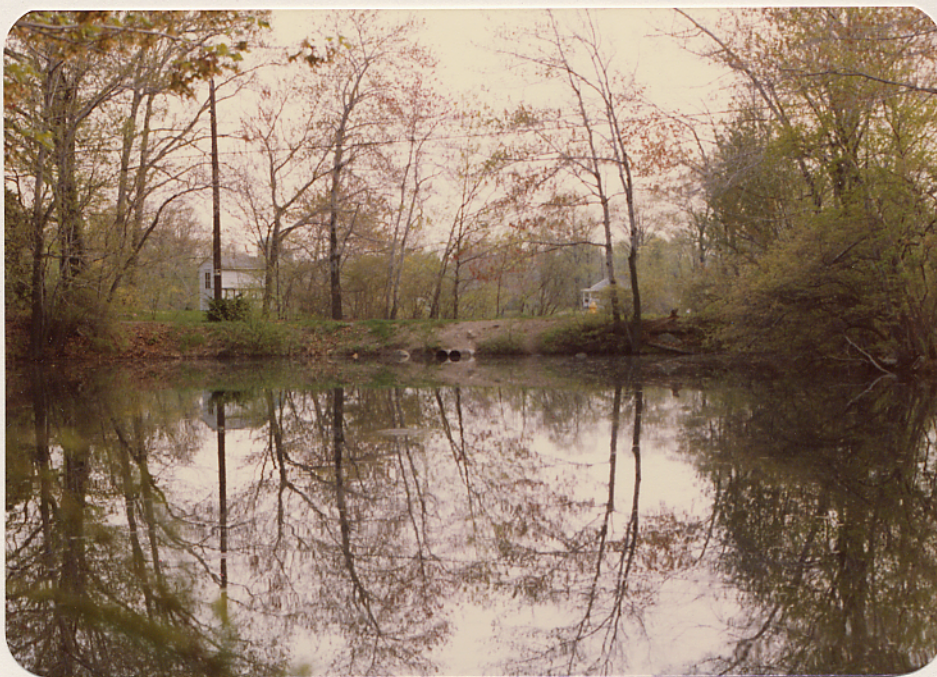
PHOTO NO. 12

At the causeway two 15-inch corrugated metal pipe culverts, Photo 12, discharge into a small pond which discharges to a natural stream through two additional 15-inch culverts.

CULVERTS AT CAUSEWAY
